Are your Pipe Supports Putting your Plant at Risk?

Regular Surveillance Protects your Plant and People

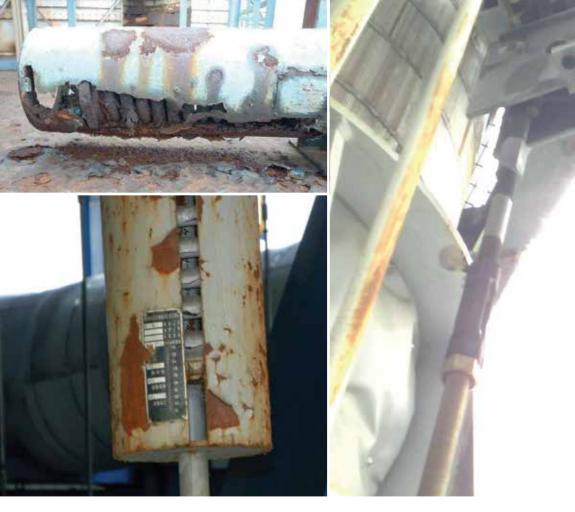
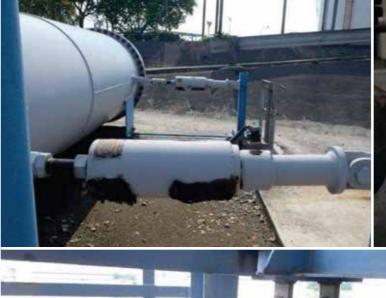
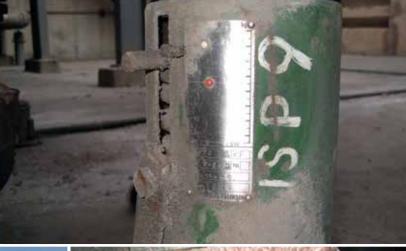
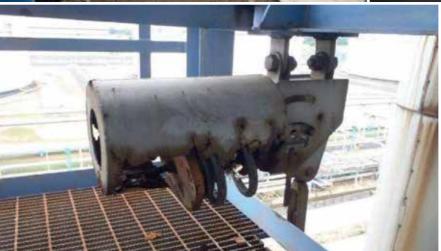
Corrosion is the real destroyer of pipe supports, as the photos show. With many units operating in very harsh conditions, it is particularly important to regularly review their condition across the site to identify and isolate problem supports, or pipework corrosion and damage, before it becomes critical.

Recent visits to a number of sites have found examples of supports in such terrible disrepair that they cannot possibly perform the task for which they were designed. While these are at the extreme end of the spectrum, many less obvious, but still important, issues can be spotted by the trained eye, ensuring repair and resolution before the problems become critical.

- Constant and variable supports with incorrect settings
- Corroded, worn and movement restricted supports
- Damaged, bent or incorrectly angled rods
- Bent and damaged pipe clamps
- Locked mechanical snubbers
- Leaking hydraulic snubbers
- Overloaded or damaged connections
- Incorrectly designed, specified or installed supports
- Buildup of debris restricting operation
- in fact anything that just 'doesn't look right' should be investigated.
